# MASTERARBEIT/MASTER'S THESIS

**„ Analysis of riverbank erosion, depositions, particle size analysis & land-use changes due to the river bank erosion in flood plain areas of Sangu river in Bangladesh“**

**Mohammad Sekandar Hossain**

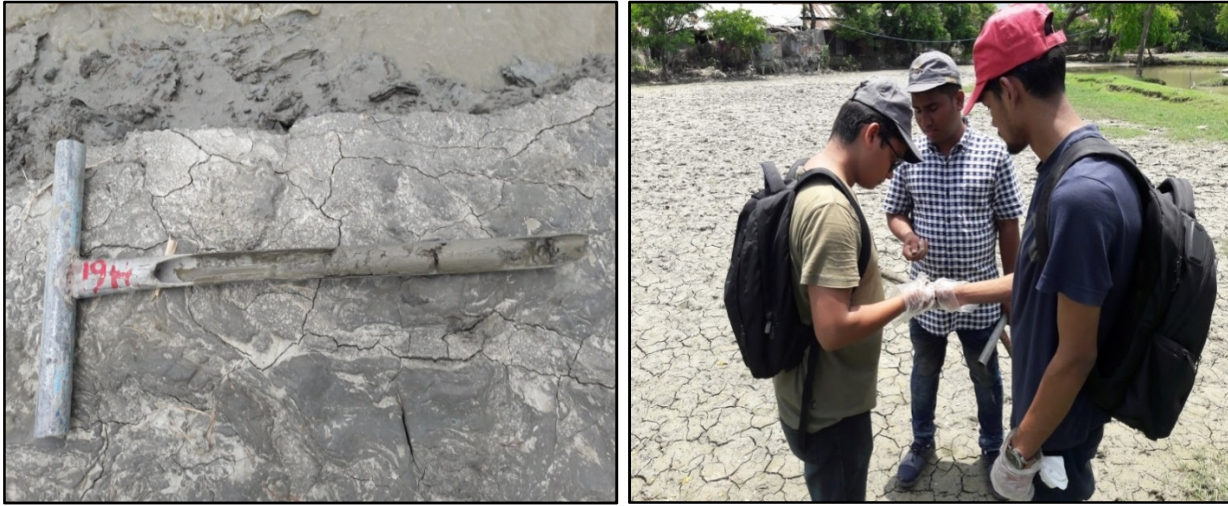
Figure 3.4: Collection of Soil sample using bore-hole and determining the sediment texture in the field.

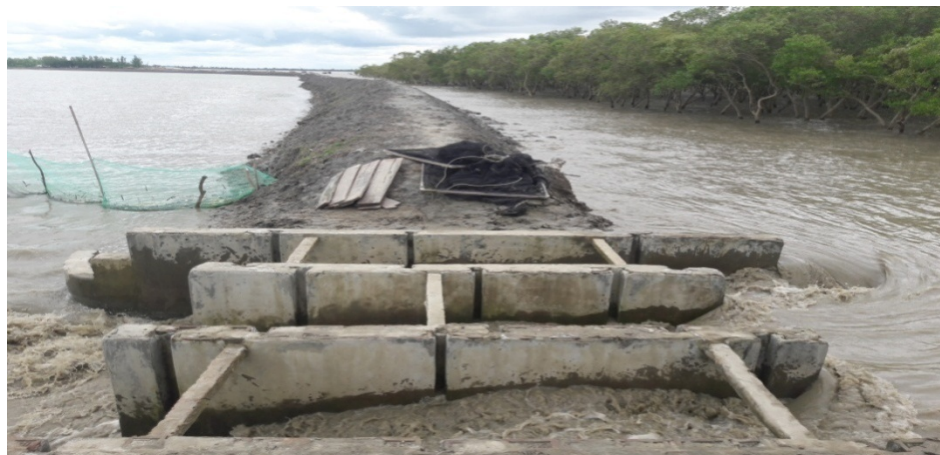
Figure 6.22: Saline water collection from the Sangu river for shrimp cultivations.

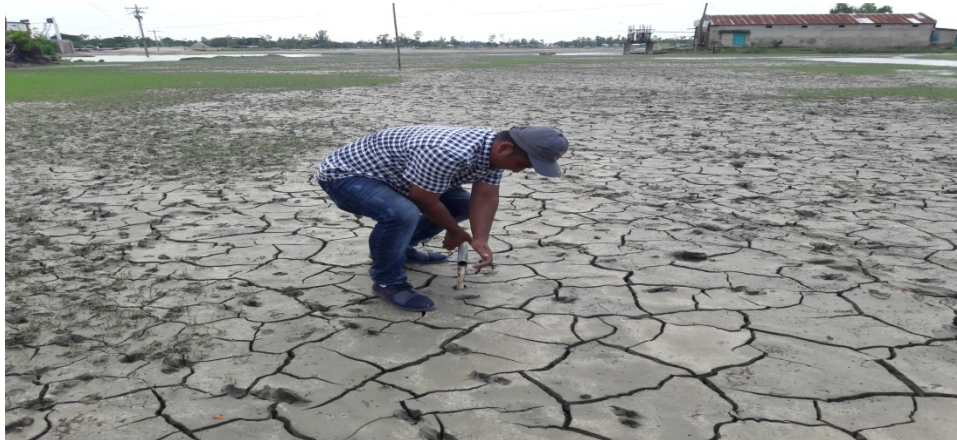
Figure 6.23: The process of agricultural land converts into fellow land due to shrimp cultivations.

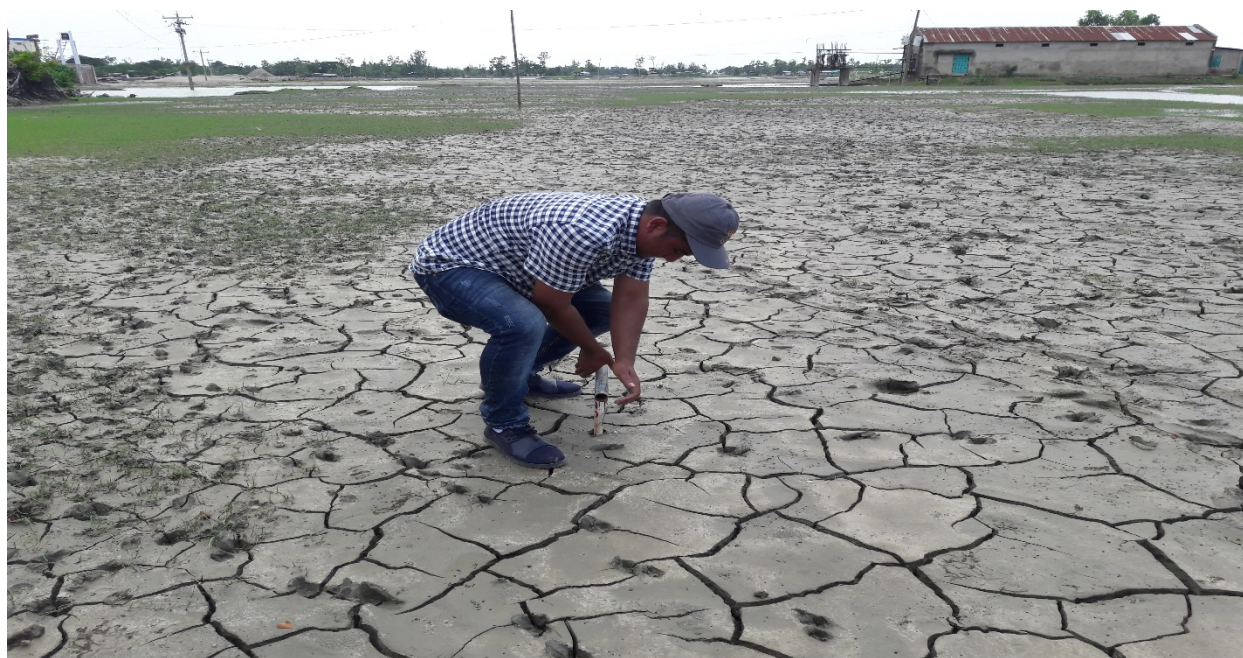
Figure: Soil Handdrilling in the Field

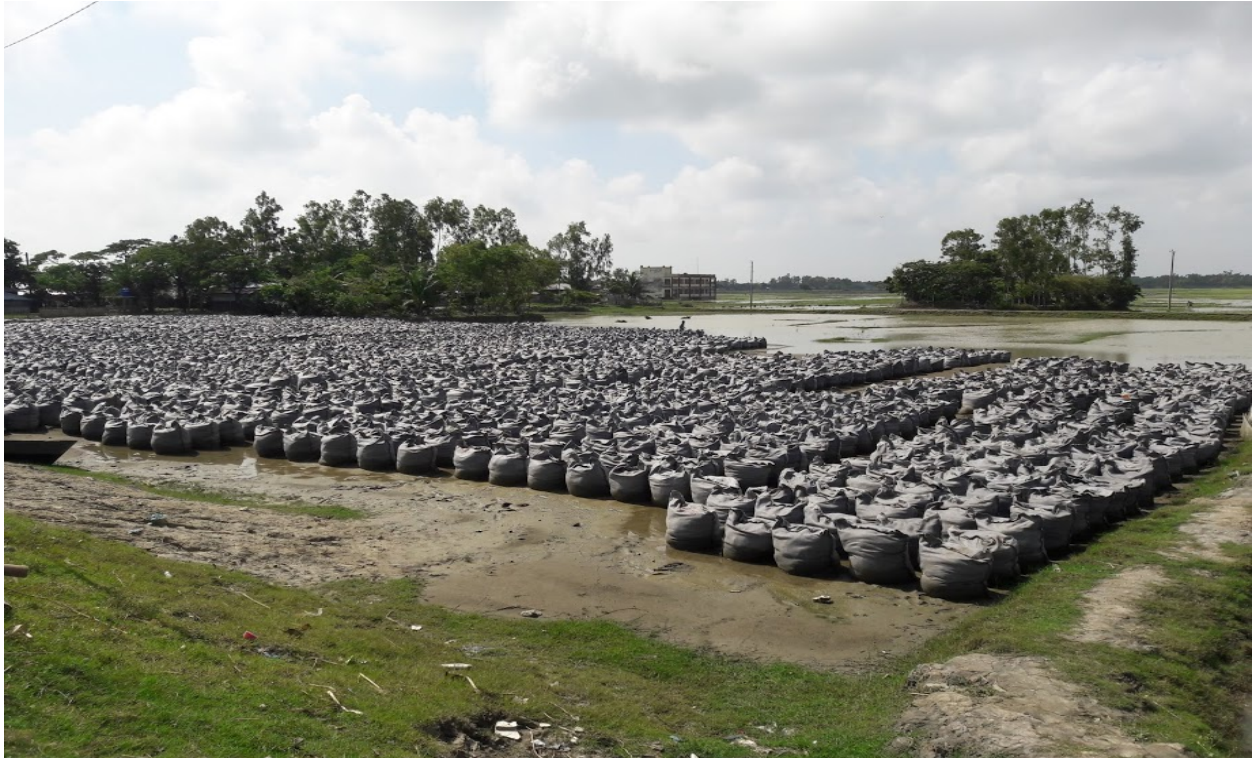
Figure: Geo-Textile bags for reduce River bank erosion in the Study area

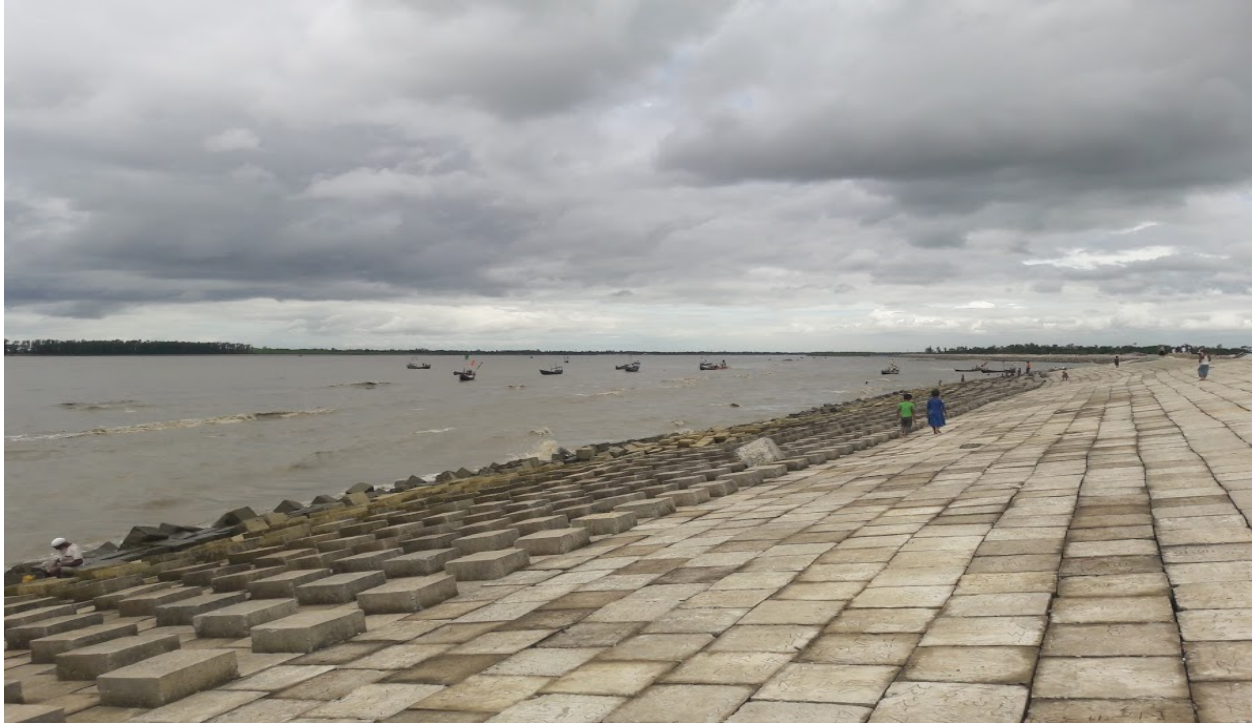
Figure: Bank Revetment process to reduce Erosion in the Study area
